Flood Control Project Maintenance
2016 Structure Summary Report
Overall Unit and Item Ratings

Lake County Watershed Protection District

Clover Creek Diversion Structure

Structure Rating	A
Date of Inspection	8/9/2016
DWR Inspector	Pavel Kazi
Accompanied By

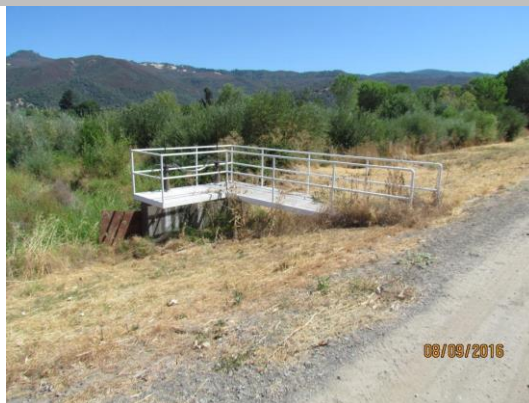
Photo 1 of 1 : ST_2016_NA0009_36_1_20160810_00011.jpg

LM Start	0.00	Rating **	N	Issue No.	1
LM End	0.00	Issue Type +	Ma	Location *	
Category	Structures & Concrete Lined Channels	GPS Latitude/Longitude			
		Start		End	
Item	Photo Documentation	39.177050 °		39.177050 °	
		-122.898750 °		-122.898750 °	
DWR ID	DWR_NA0009_36_t_2012_1				
Action/Comments					
Inspector Comments: Clover Creek Diversion Structure has three culverts with two slide gates, and a gate to divert the water during high water season.

View of the structure.

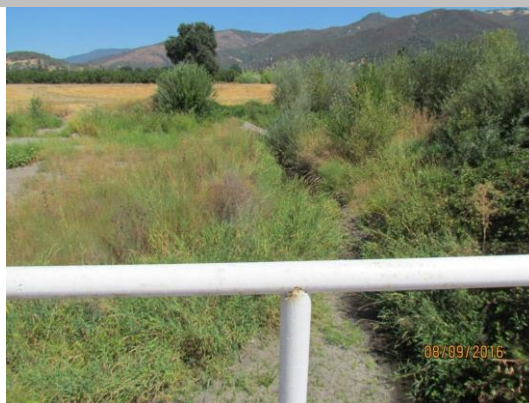
Photo 1 of 2 : ST_2016_NA0009_36_2_20160811_00013.jpg

LM Start	0.00	Rating **	A	Issue No.	2
LM End	0.00	Issue Type +	Ma	Location *	
Category	Structures & Concrete Lined Channels	GPS Latitude/Longitude			
		Start		End	
Item	Vegetation & Obstructions	39.177050 °		39.177050 °	
		-122.898750 °		-122.898750 °	
DWR ID	DWR_NA0009_36_t_2012_2				
Action/Comments					
Inspector Comments: The channel had minimal vegetation and scattered obstructions, but the flow is not impeded.

View of the vegetation at the inlet of the structure.

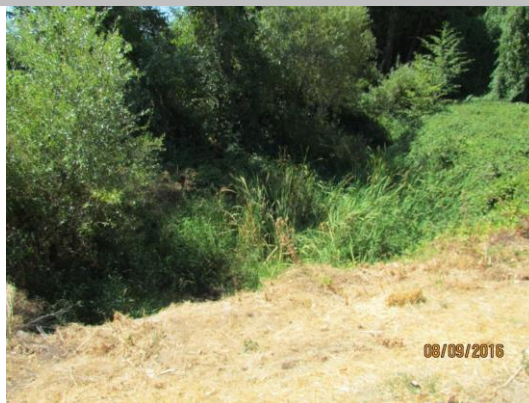
Photo 2 of 2 : ST_2016_NA0009_36_2_20160811_00012.jpg

View of the vegetation at the outlet of the structure.

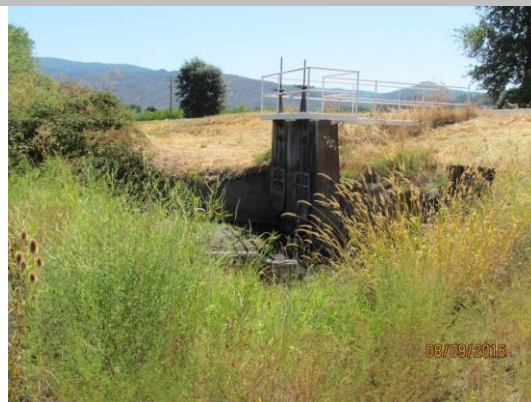
Photo 1 of 2 : ST_2016_NA0009_36_7_20160811_00014.jpg

LM Start	0.00	Rating **	M	Issue No.	7
LM End	0.00	Issue Type +	Ma	Location *	
Category	Structures & Concrete Lined Channels	GPS Latitude/Longitude			
		Start	End		
Item	Culverts: Inlets / Outlets	39.177050 °		39.177050 °	
		-122.898750 °		-122.898750 °	
DWR ID	DWR_NA0009_36_t_2012_7				
Action/Comments					
Inspector Comments: Vegetation was found on the outlet culvert of the structure.

View of the inlet culvert.

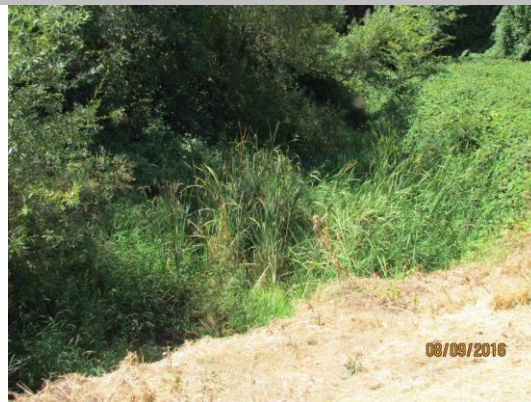
Photo 2 of 2 : ST_2016_NA0009_36_7_20160811_00015.jpg

View of the outlet culvert.

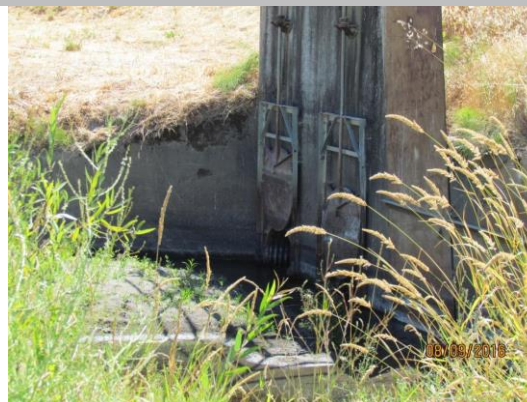
Photo 1 of 1 : ST_2016_NA0009_36_12_20160811_00016.jpg

LM Start	0.00	Rating **	A	Issue No.	12
LM End	0.00	Issue Type +	Ma	Location *	
Category	Structures & Concrete Lined Channels	GPS Latitude/Longitude			
		Start		End	
Item	Sluice/Slide Gates	39.177050 °		39.177050 °	
		-122.898750 °		-122.898750 °	
DWR ID	DWR_NA0009_36_t_2012_12				
Action/Comments					
Inspector Comments: The slide gates appeared to be in good working condition.

View of the slide gates.

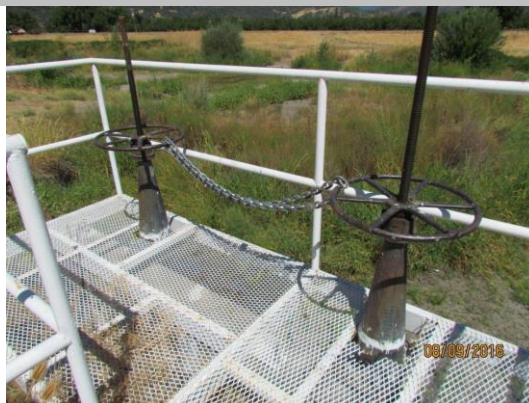
Photo 1 of 2 : ST_2016_NA0009_36_14_20160811_00017.jpg

LM Start	0.00	Rating **	A	Issue No.	14
LM End	0.00	Issue Type +	Ma	Location *	
Category	Structures & Concrete Lined Channels			GPS Latitude/Longitude	
				Start	End
Item	Manual Gate Operators			39.177050 °	39.177050 °
				-122.898750 °	-122.898750 °
DWR ID	DWR_NA0009_36_t_2012_14				
Action/Comments					
Inspector Comments: The manual gate operators appeared to be operational.

View of the manual gate operator during 2016 inspection.

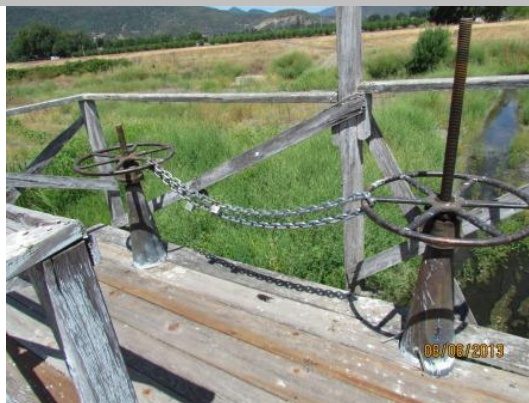
Photo 2 of 2 : ST_2016_NA0009_36_14_20160613_00008.jpg

View of the manual gate operator during 2013 inspection.

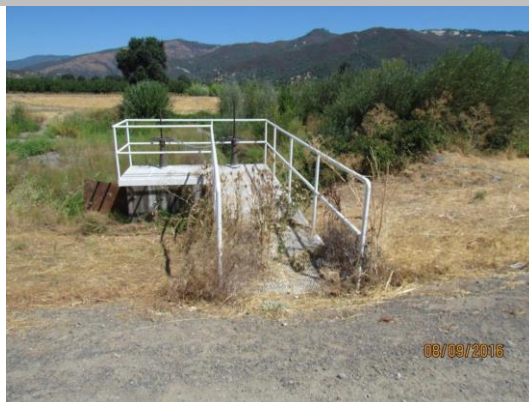
Photo 1 of 2 : ST_2016_NA0009_36_23_20160811_00018.jpg

LM Start	0.00	Rating **	A	Issue No.	23
LM End	0.00	Issue Type +	Ma	Location *	
Category	Structures & Concrete Lined Channels			GPS Latitude/Longitude	
				Start	End
Item	Safety			39.177050 °	39.177050 °
				-122.898750 °	-122.898750 °
DWR ID	DWR_NA0009_36_t_2012_23				
Action/Comments					
Inspector Comments: New steel handrail was placed around the structure. No safety hazard was present.

View of the handrails on the structure during 2016 inspection.

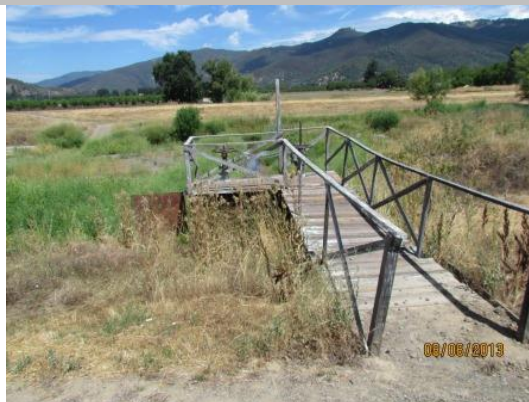
Photo 2 of 2 : ST_2016_NA0009_36_23_20160613_00010.jpg

View of the wooden guard rail during 2013 inspection.
